**Fire Resistance Test
on
ASMACO Fire Stop Silicone Sealant**

**Test Sponsor:
Anchor Allied Factory L.L.C.**

Fire Resistance of ASMACO Fire Stop Silicone Sealant

Testing Laboratory : Material Lab
Lab Report No. : CR-170406/16738 SN 1/2
Lab Project No. : P-3833
Test Reference No. : 170406473
Test Standard : BS 476: Part 22: 1987: Amd 2014.

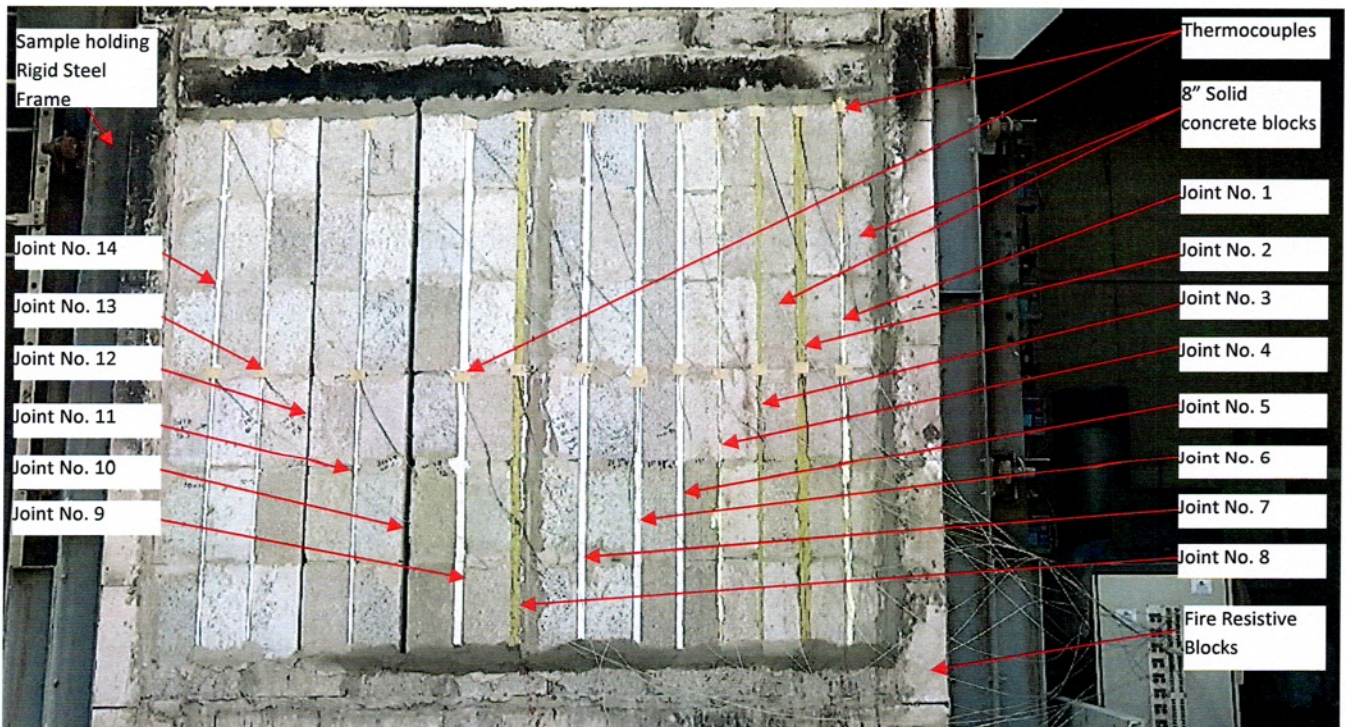
Figure 1: Test specimen mounted in frame for testing

A rigid steel frame with fire resistive concrete blocks fixed on its internal perimeter having an opening of 3.03 x 3.03 meter was used to prepare the specimen for testing. Supporting construction comprising of only 8" solid blocks was prepared in the test frame by the laboratory's skilled workers.

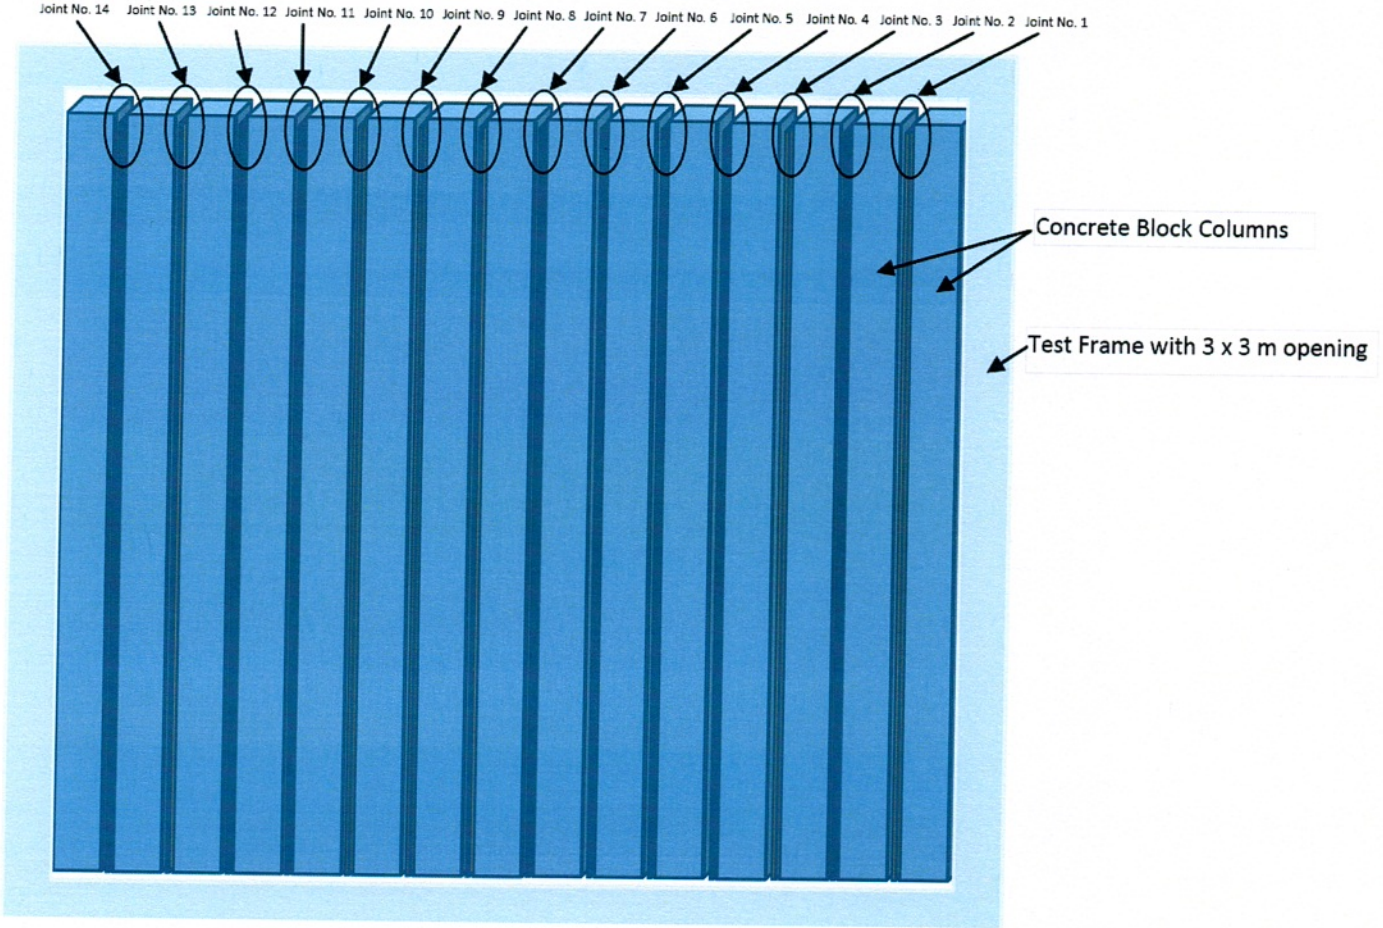
Wall Construction Arrangements with Vertical Sealant Strips between Blocks:

Figure 2.1: Supporting construction arrangement, non – fire side view

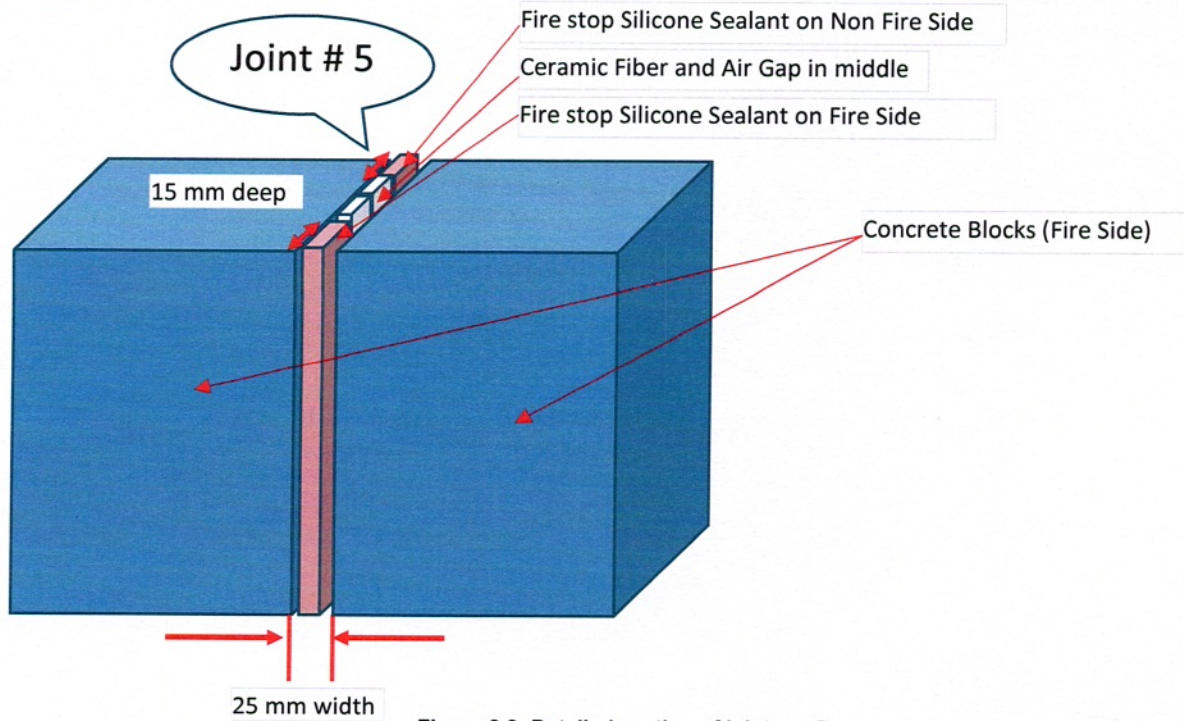
Figure 2.2: Detailed section of joint no. 5

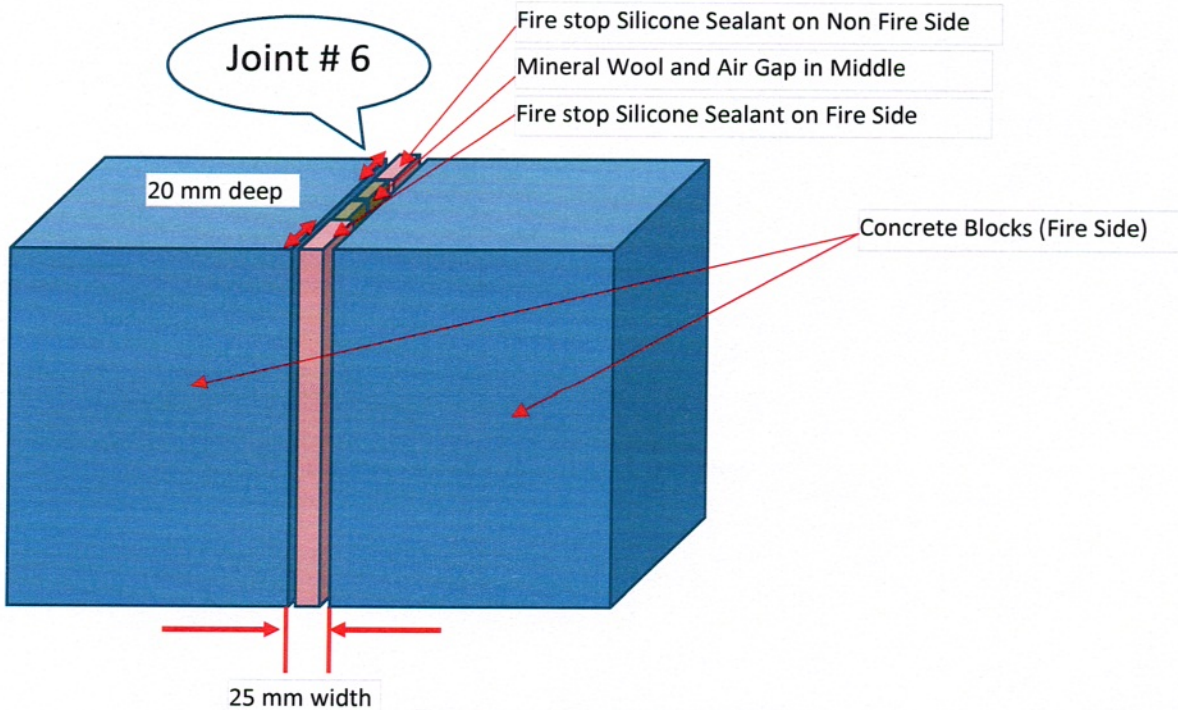
Figure 2.3: Detailed section of joint no. 6

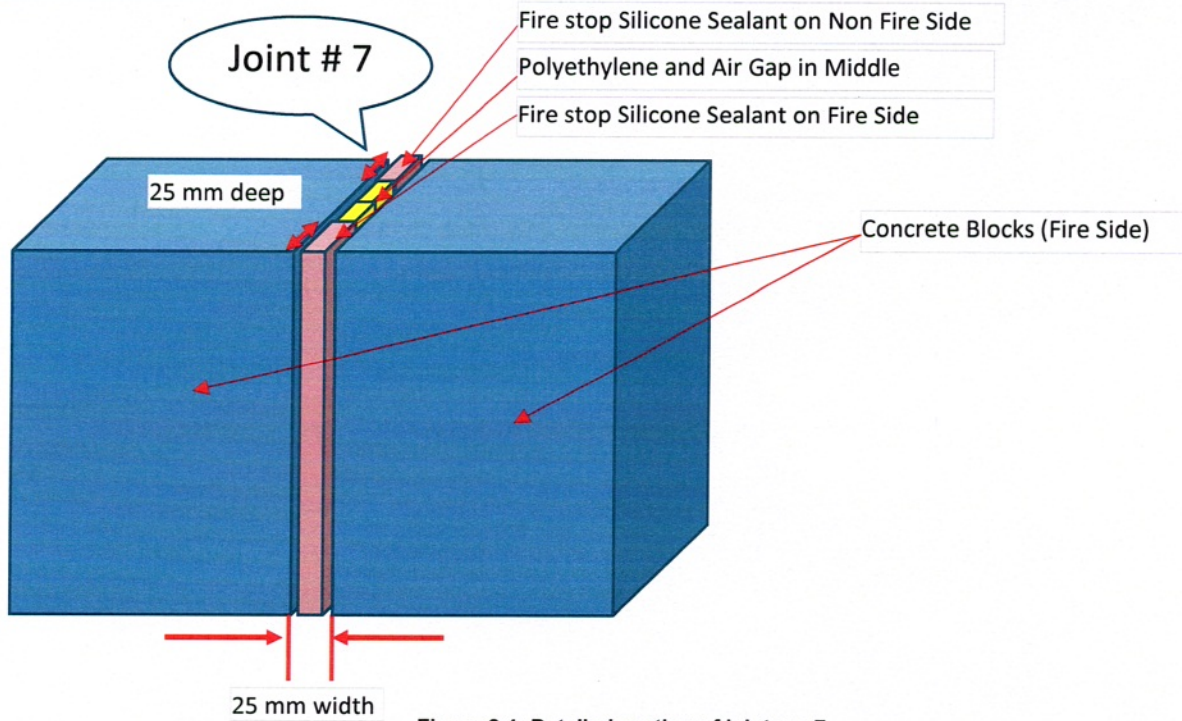
Figure 2.4: Detailed section of joint no. 7

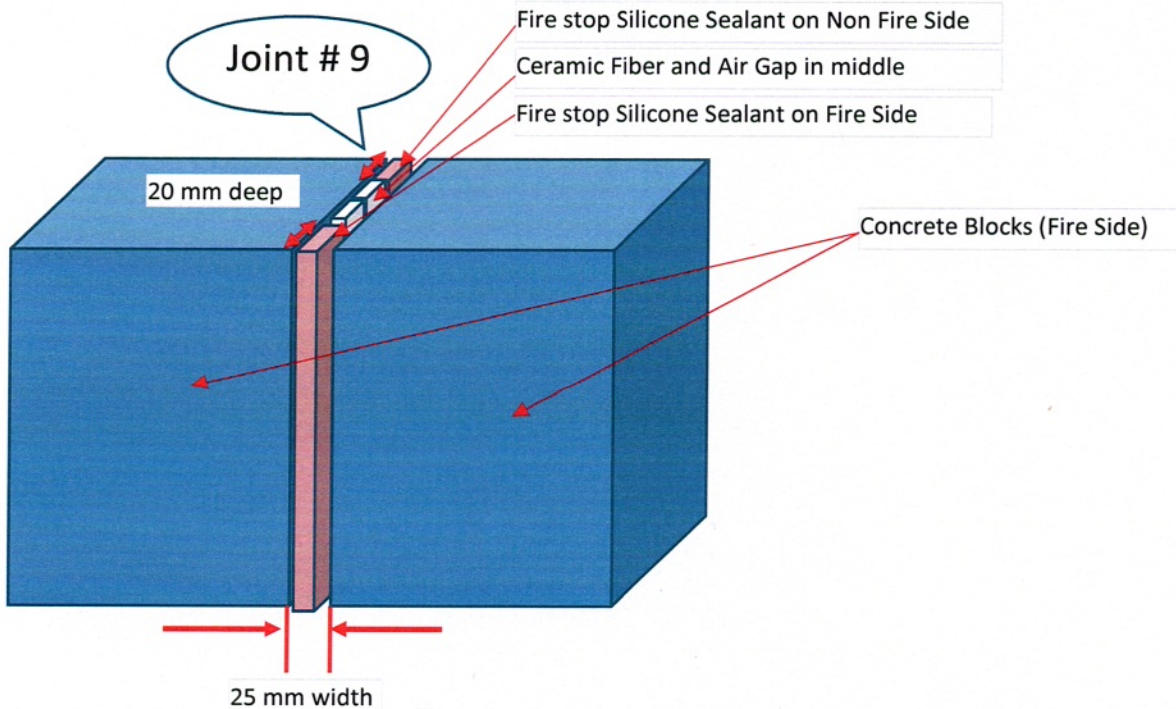
Figure 2.5: Detailed section of joint no. 9

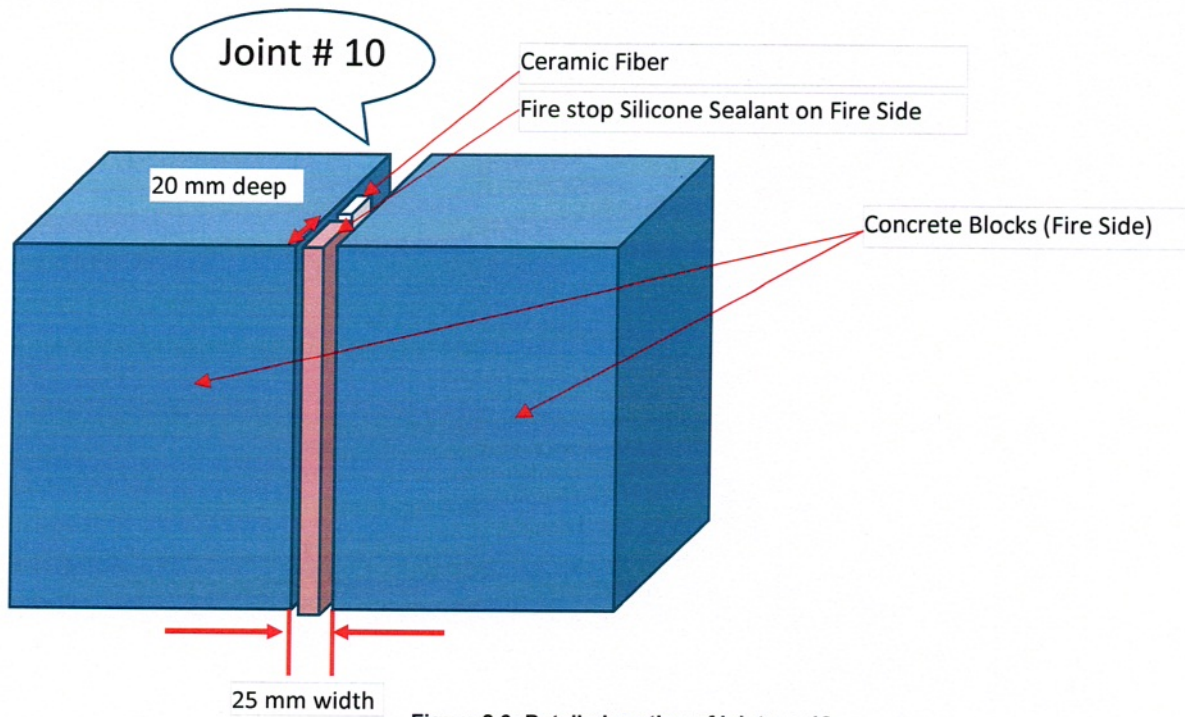
Figure 2.6: Detailed section of joint no. 10

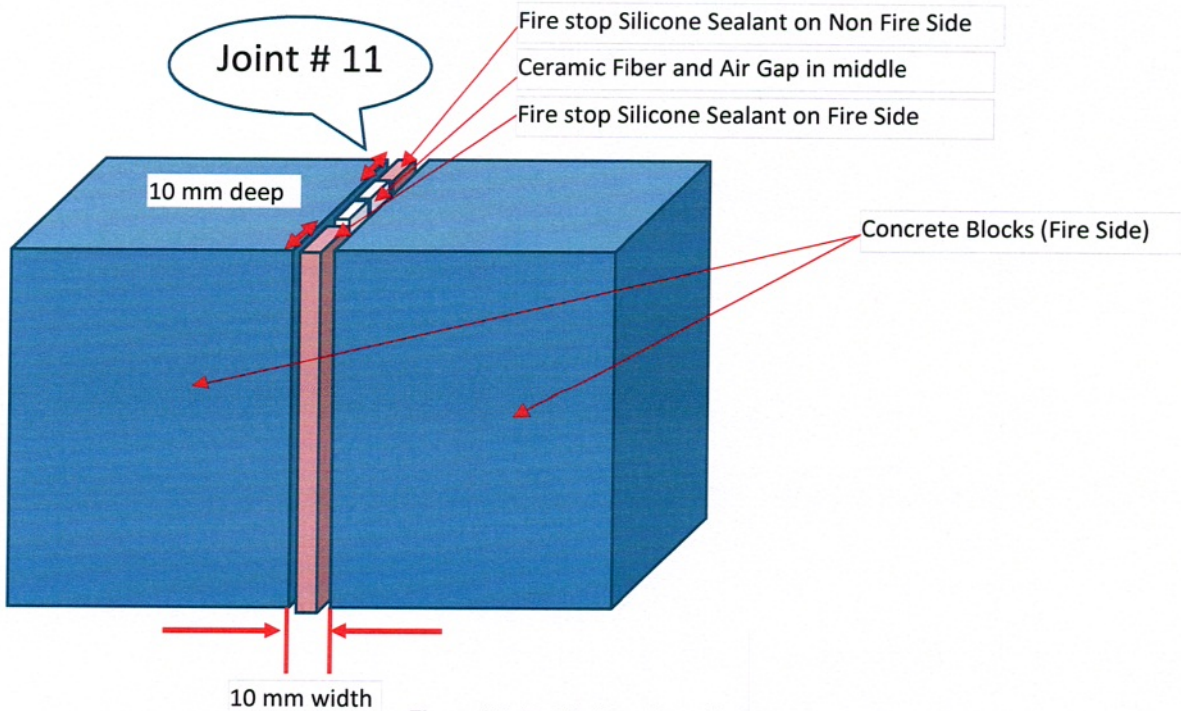
Figure 2.7: Detailed section of joint no. 11

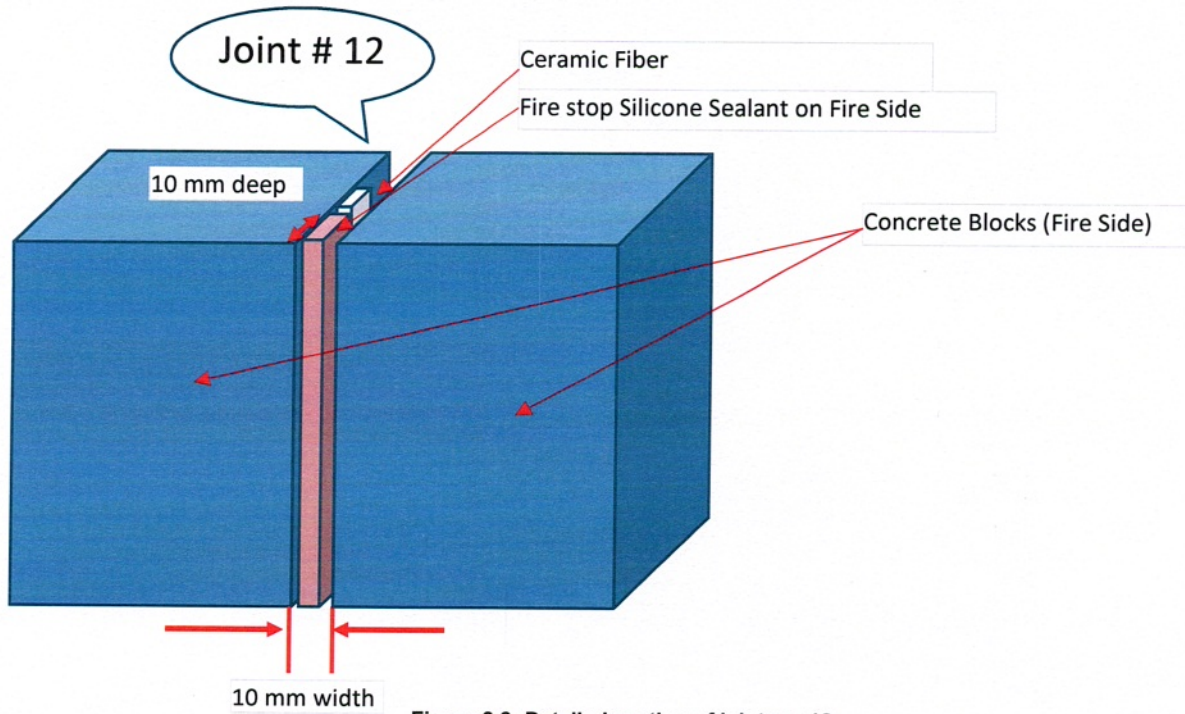
Figure 2.8: Detailed section of joint no. 12

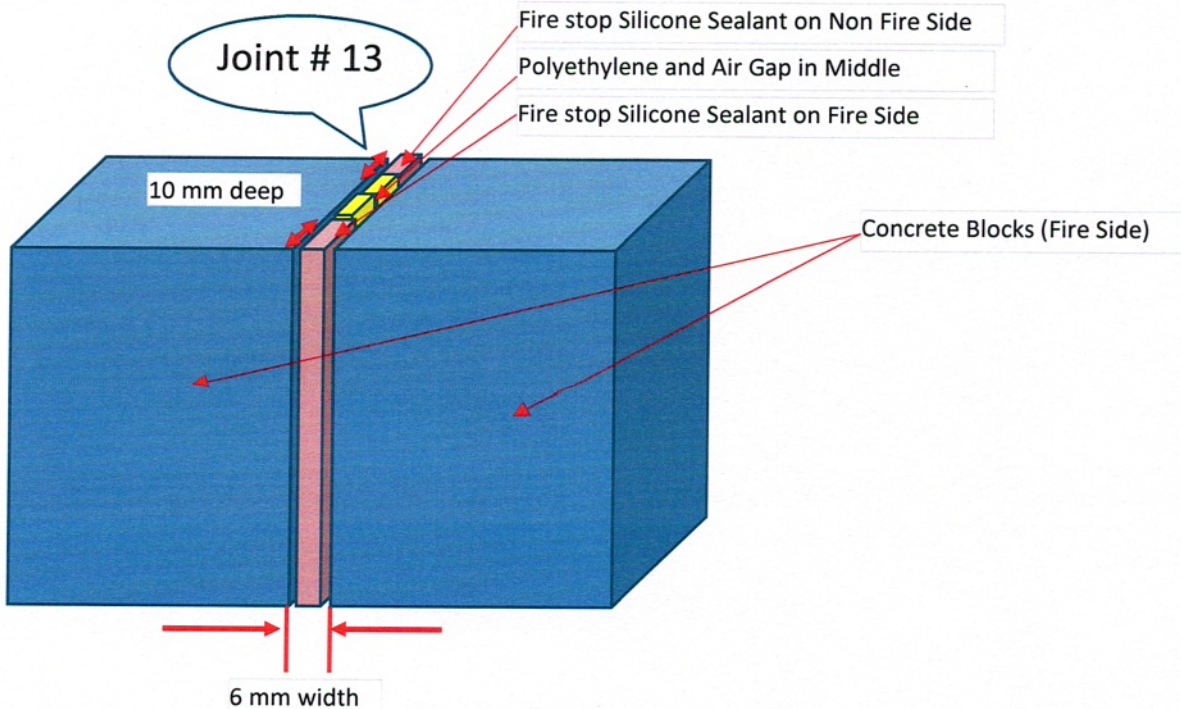
Figure 2.9: Detailed section of joint no. 13

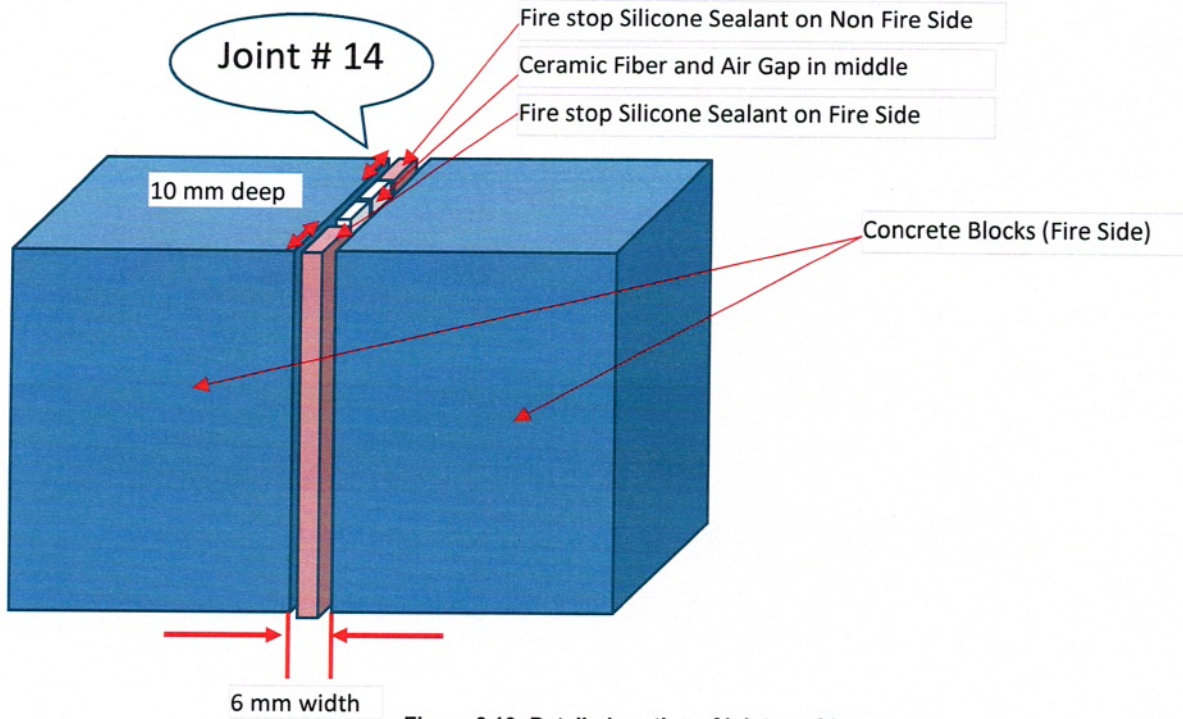
Figure 2.10: Detailed section of joint no. 14

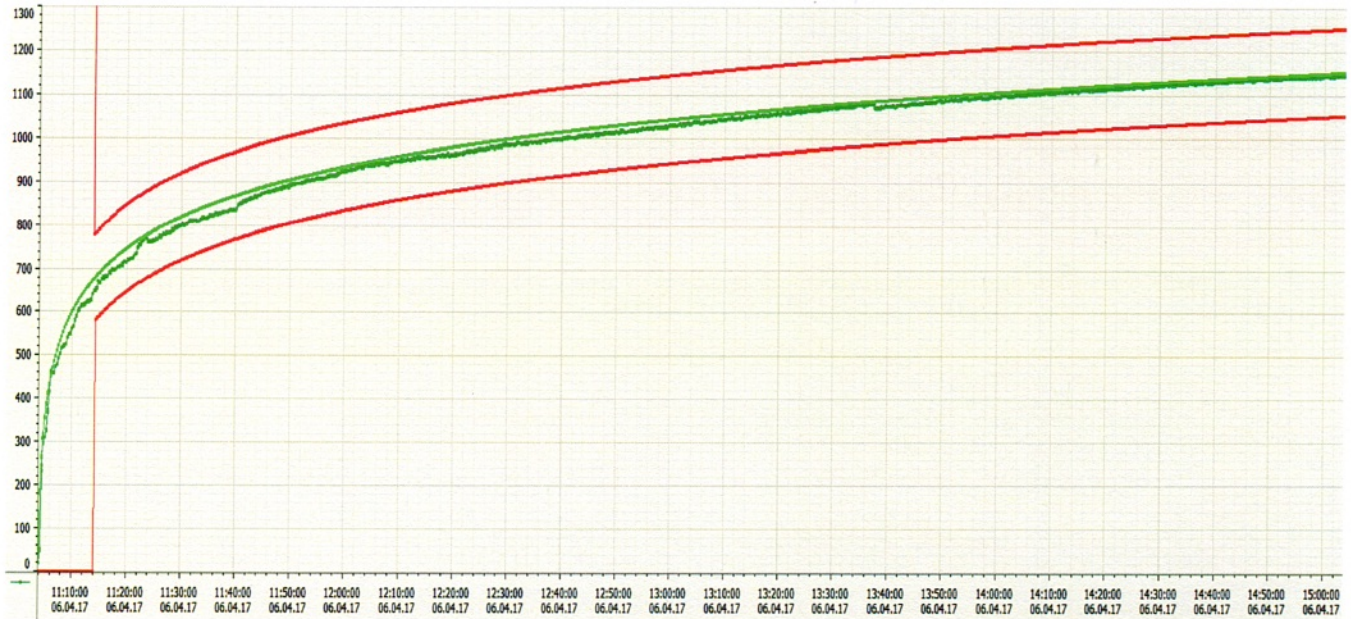
Figure 3: Furnace internal temperature graph for complete duration of test

Furnace conditions during the test, such as temperature and pressure, were kept in accordance with clause 3 of BS 476: Part 20: 1987: Amd 2014. During the test a neutral pressure plane was set up 1m above the furnace floor and the pressure at the top of the furnace was not allowed to exceed 20 Pa.

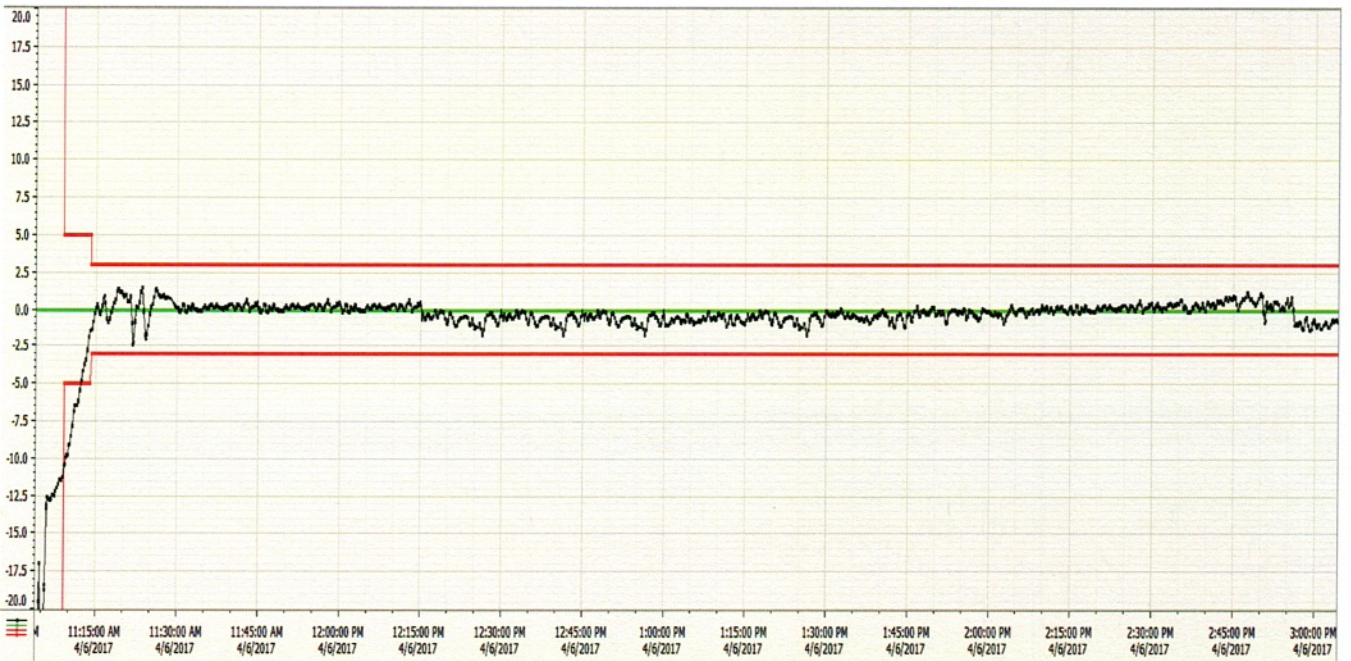
Figure 4: Furnace internal pressure graph for complete duration of test

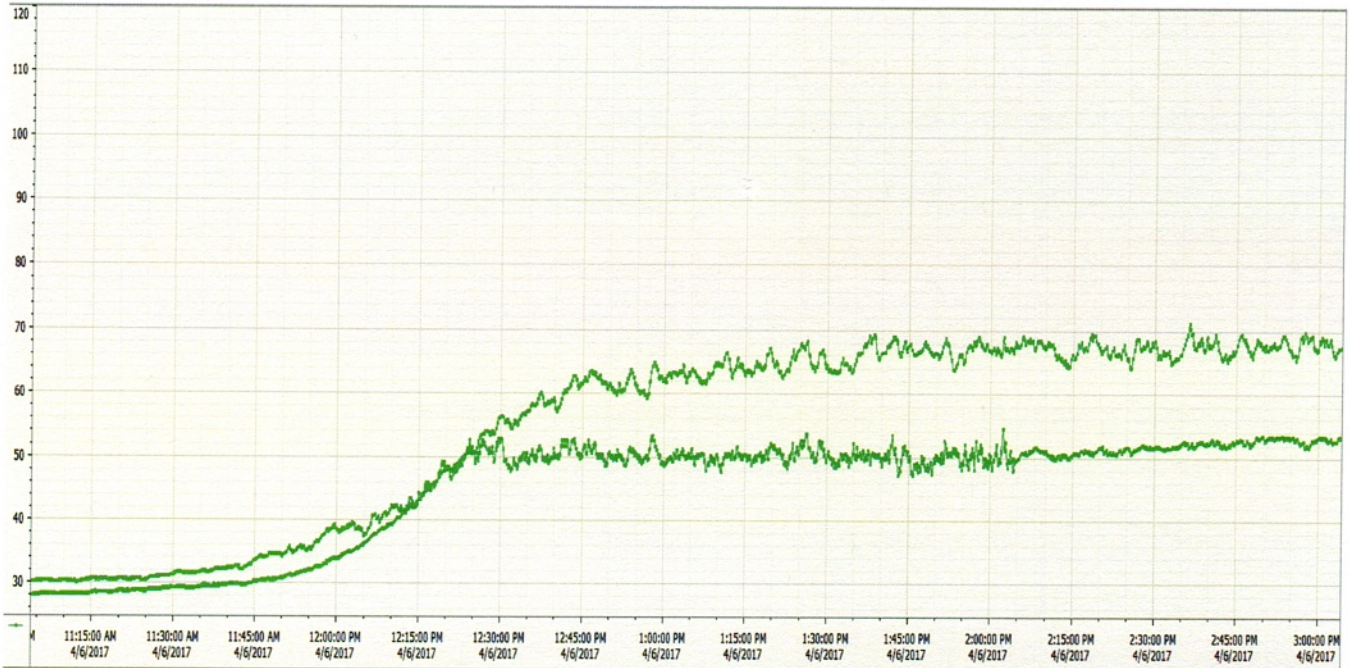
Figure 5: Thermocouples TC-9 & TC-10 representing unexposed surface temperature on joint no. 5 up till end of testing

| ASMACO Fire stop Silicone Sealant (Width x Depth : 25mm x 15mm) with Both Side Application and Ceramic Fiber Backup, Ref.: Joint No. 5 | | |
|--|---|---|
| 1. Maximum Temperature | - | No failure. Maximum temperature recorded after 240 minutes of testing was 68°C on TC-10 which did not exceed standard limits. |

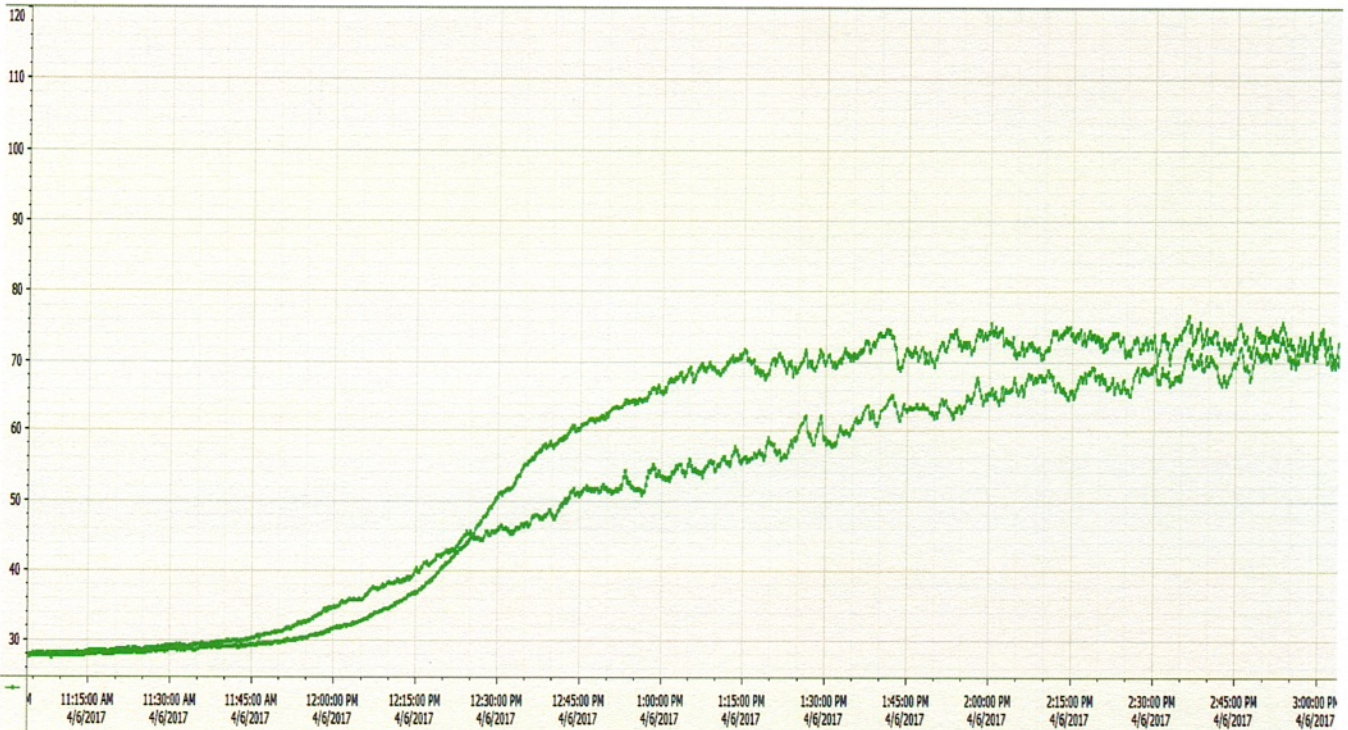
Figure 6: Thermocouples TC-11 & TC-12 representing unexposed surface temperature on joint no. 6 up till end of testing

| ASMACO Fire stop Silicone Sealant (Width x Depth : 25mm x 20mm) with Both Side Application and Mineral wool Backup, Ref.: Joint No. 6 | | |
|---|---|---|
| 1. Maximum Temperature | - | No failure. Maximum temperature recorded after 240 minutes of testing was 73°C on TC-12 which did not exceed standard limits. |

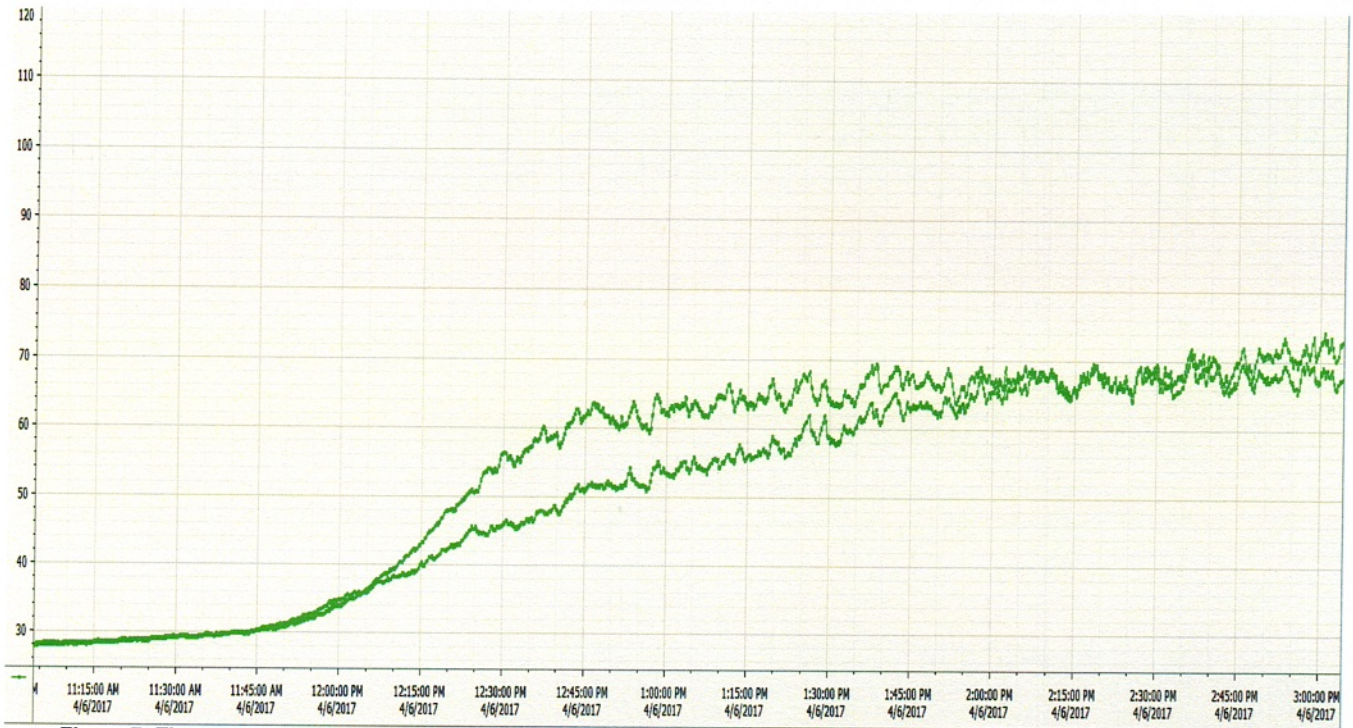
Figure 7: Thermocouples TC-13 & TC-14 representing unexposed surface temperature on joint no. 7 up till end of testing

| ASMACO Fire stop Silicone Sealant (Width x Depth : 25mm x 25mm) with Both Side Application and Polyethylene Backup, Ref.: Joint No. 7 | | |
|---|---|---|
| 1. Maximum Temperature | - | No failure. Maximum temperature recorded after 240 minutes of testing was 71°C on TC-14 which did not exceed standard limits. |

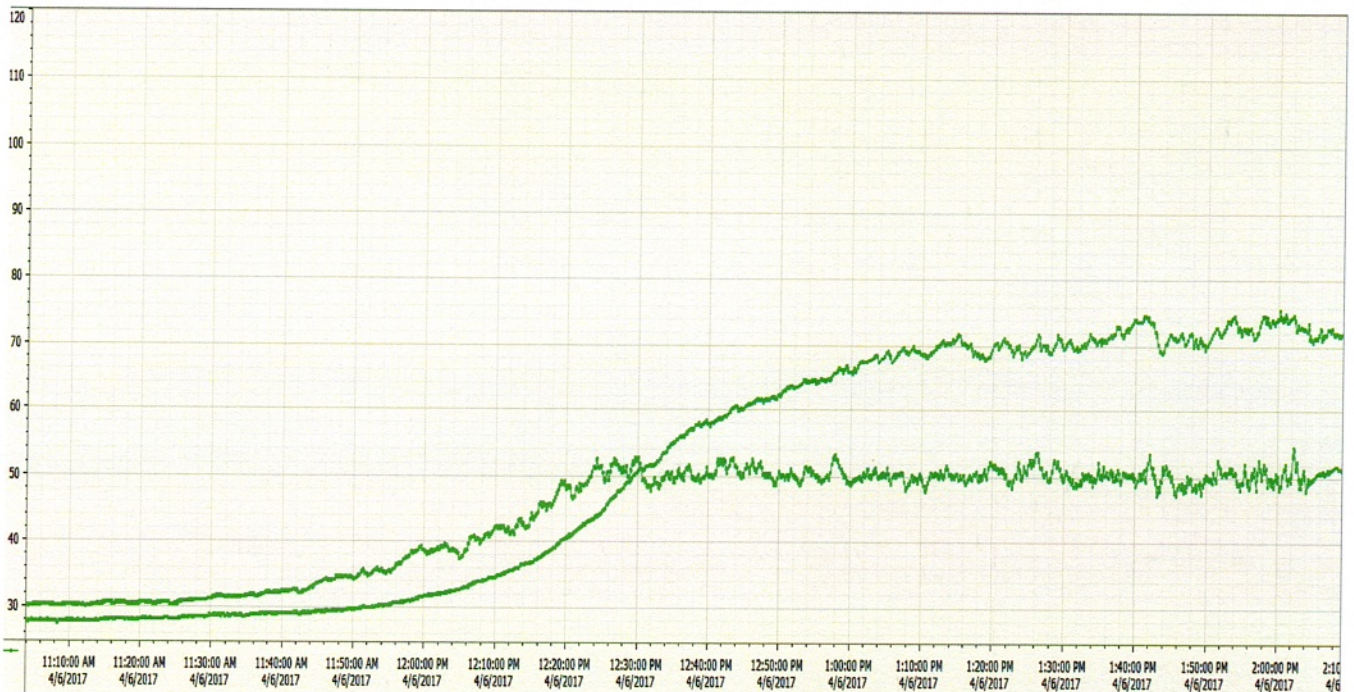
Figure 8: Thermocouples TC-17 & TC-18 representing unexposed surface temperature on joint no. 9 up till end of testing

| ASMACO Fire stop Silicone Sealant (Width x Depth : 25mm x 20mm) with Both Side Application and Ceramic Fiber Backup, Ref.: Joint No. 9 | | |
|--|---|---|
| 1. Maximum Temperature | - | No failure. Maximum temperature recorded after 240 minutes of testing was 71°C on TC-18 which did not exceed standard limits. |

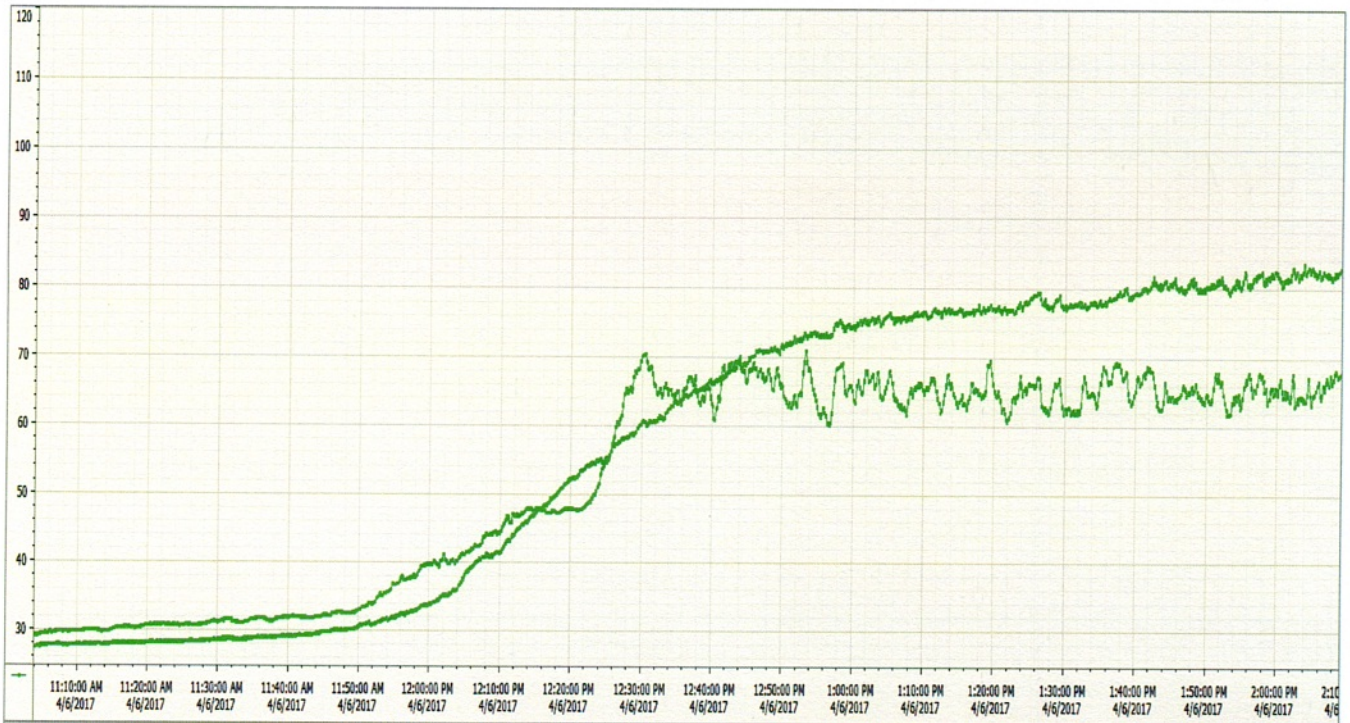
Figure 9: Thermocouples TC-19 & TC-20 representing unexposed surface temperature on joint no. 11 up till end of testing

| ASMACO Fire stop Silicone Sealant (Width x Depth : 10mm x 10mm) with Both Side Application and Ceramic Fiber Backup, Ref.: Joint No. 11 | | |
|---|---|---|
| 1. Maximum Temperature | - | No failure. Maximum temperature recorded after 240 minutes of testing was 82°C on TC-20 which did not exceed standard limits. |

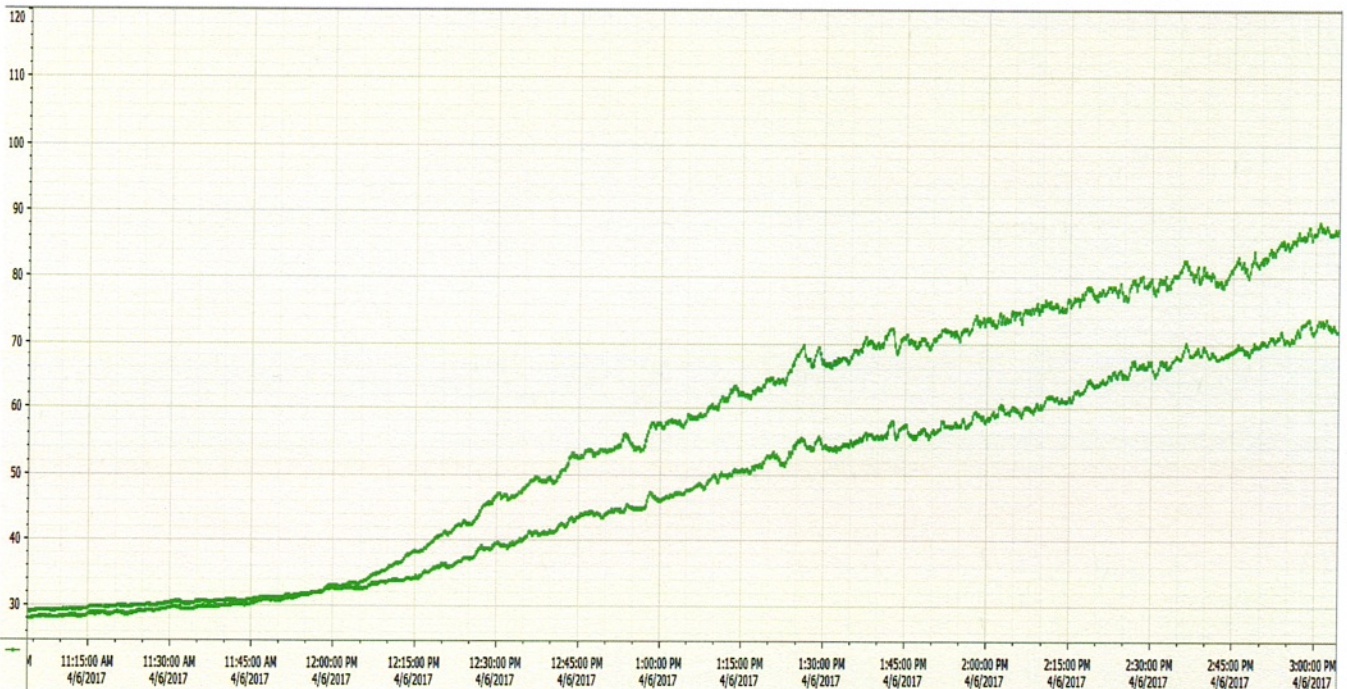
Figure 10: Thermocouples TC-21 & TC-22 representing unexposed surface temperature on joint no. 13 up till end of testing

| ASMACO Fire stop Silicone Sealant (Width x Depth : 6mm x 10mm) with Both Side Application and Polyethylene Backup, Ref.: Joint No. 13 | | |
|---|---|---|
| 1. Maximum Temperature | - | No failure. Maximum temperature recorded after 240 minutes of testing was 89°C on TC-22 which did not exceed standard limits. |

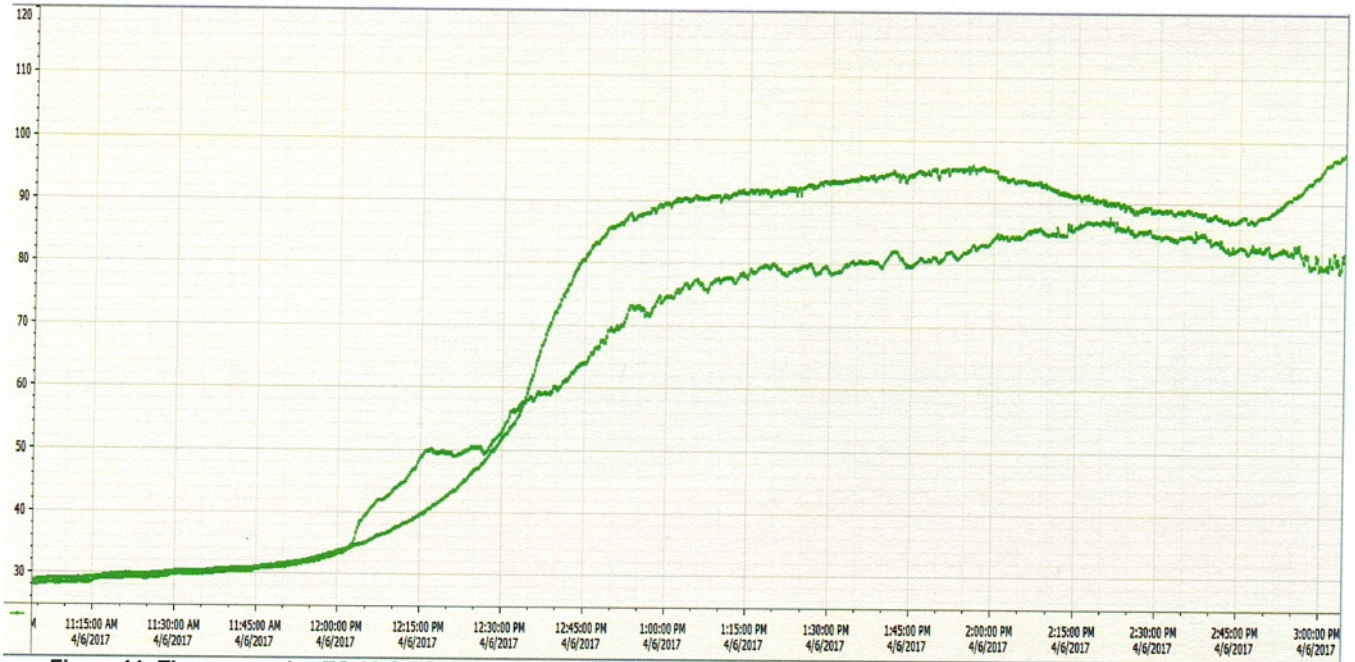
Figure 11: Thermocouples TC-23 & TC-24 representing unexposed surface temperature on joint no. 14 up till end of testing

| ASMACO Fire stop Silicone Sealant (Width x Depth : 6mm x 10mm) with Both Sides Application and Ceramic Fiber Backup, Ref.: Joint No. 14 | | |
|---|---|---|
| 1. Maximum Temperature | - | No failure. Maximum temperature recorded after 240 minutes of testing was 99°C on TC-24 which did not exceed standard limits. |

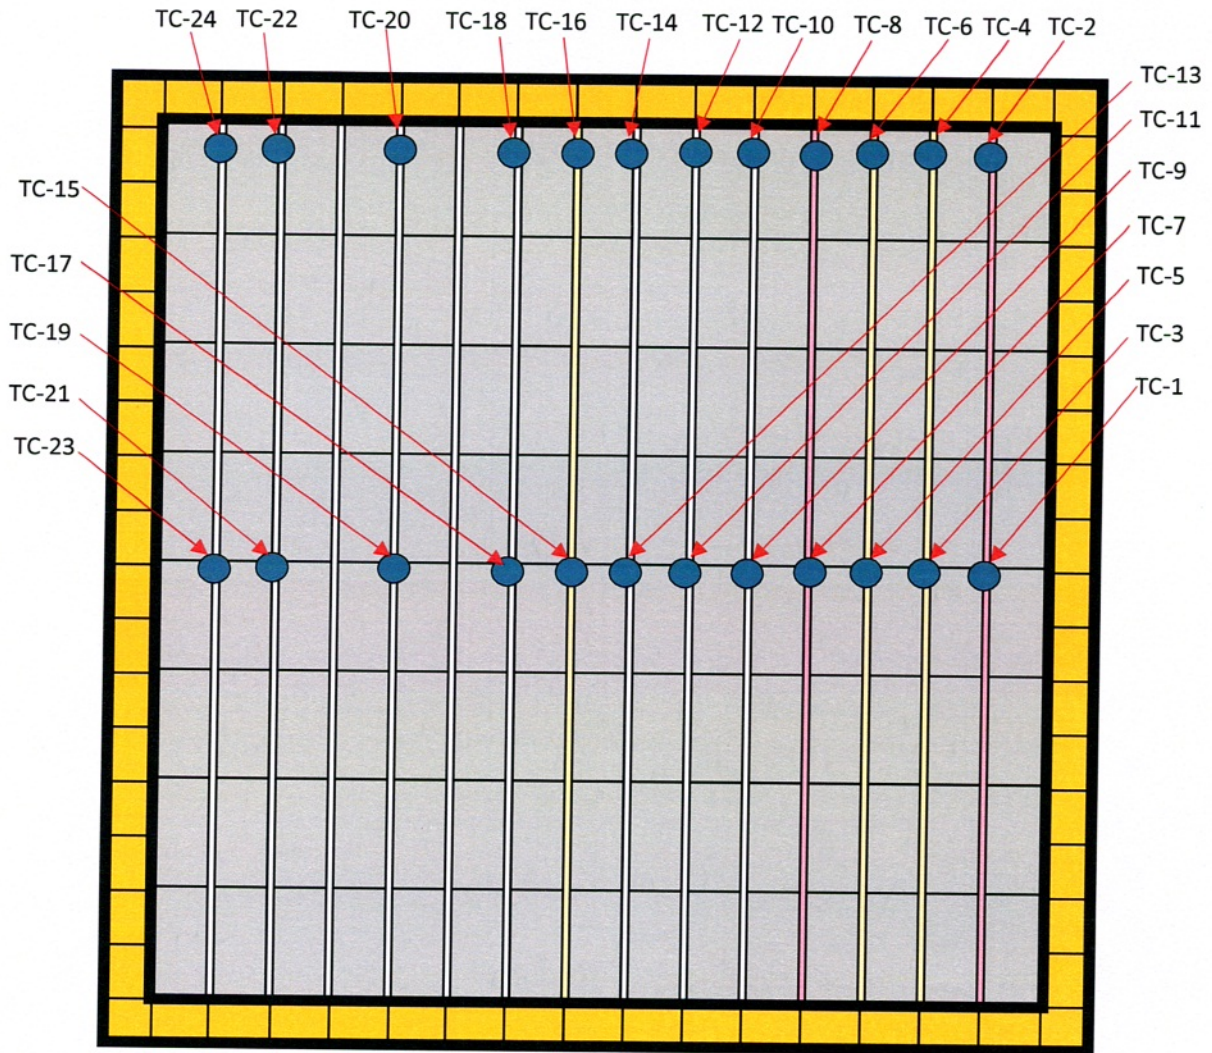
Instrumentation Positioning (All dimensions are in 'mm'):

For measurement of insulation criteria only maximum rise in temperature on the unexposed surface of the sealants was determined. In addition, the thermocouples were only fixed to every ASMACO Fire stop silicone sealant joint where the sealant was applied on both sides and on every joint containing the ASMACO Gold Multi-

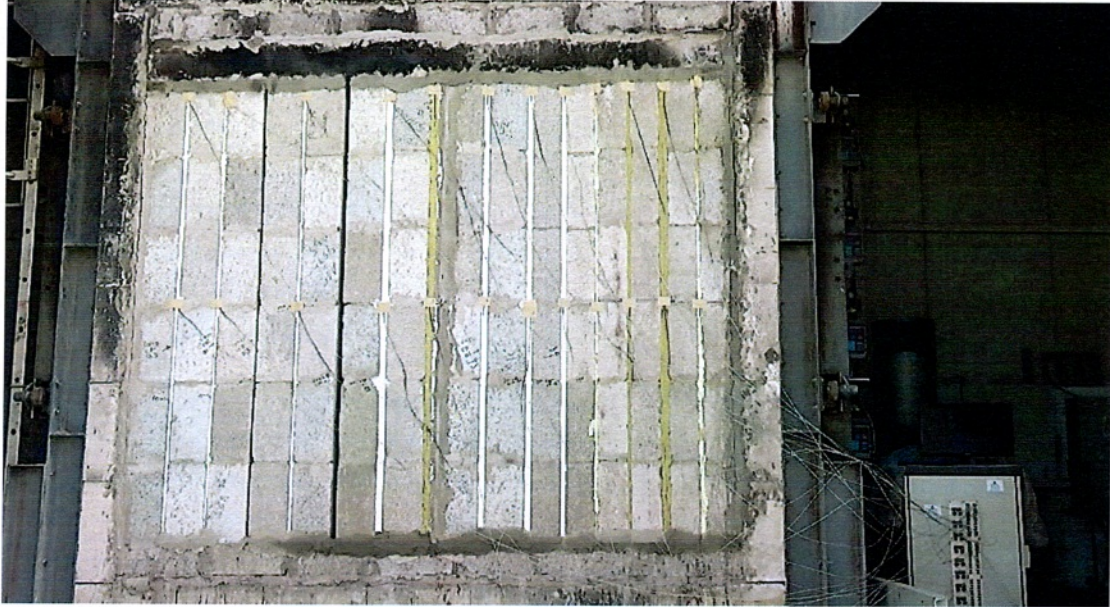
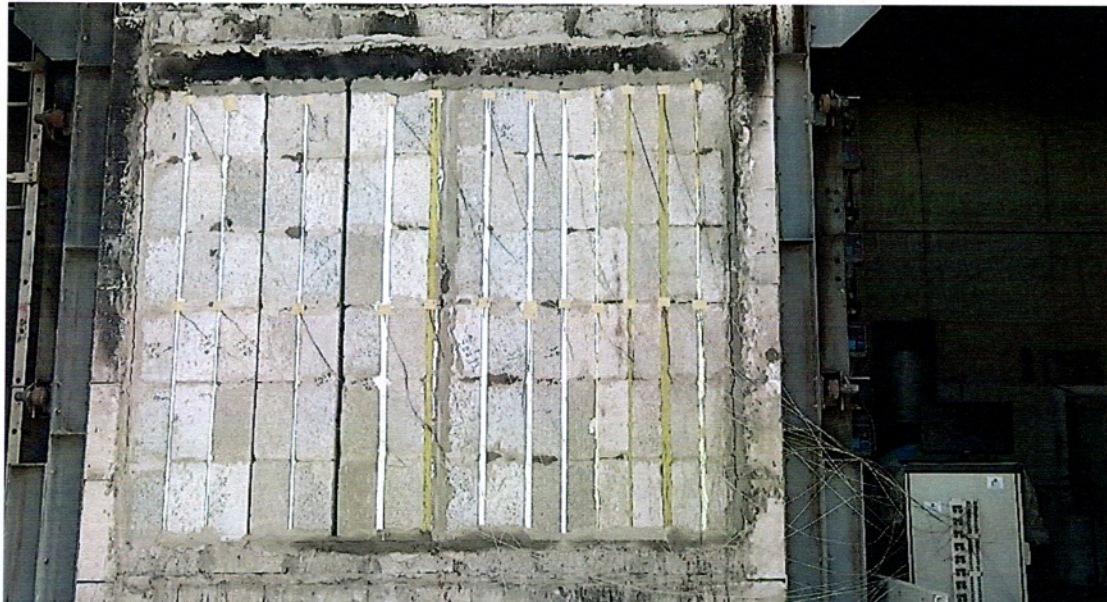
Specimen after 30mins of testing

Specimens after 60mins of testing

Figure 14.1: Unexposed side of specimen during exposure to fire
