**Fire Resistance Test
on
ASMACO Fire Stop Silicone Sealant**

**Test Sponsor:
Anchor Allied Factory L.L.C.**

Fire Resistance of ASMACO Fire Stop Silicone Sealant

Testing Laboratory : Material Lab
Lab Report No. : CR-170406/16738 SN 1/2
Lab Project No. : P-3833
Test Reference No. : 170406473
Test Standard : BS 476: Part 22: 1987: Amd 2014.

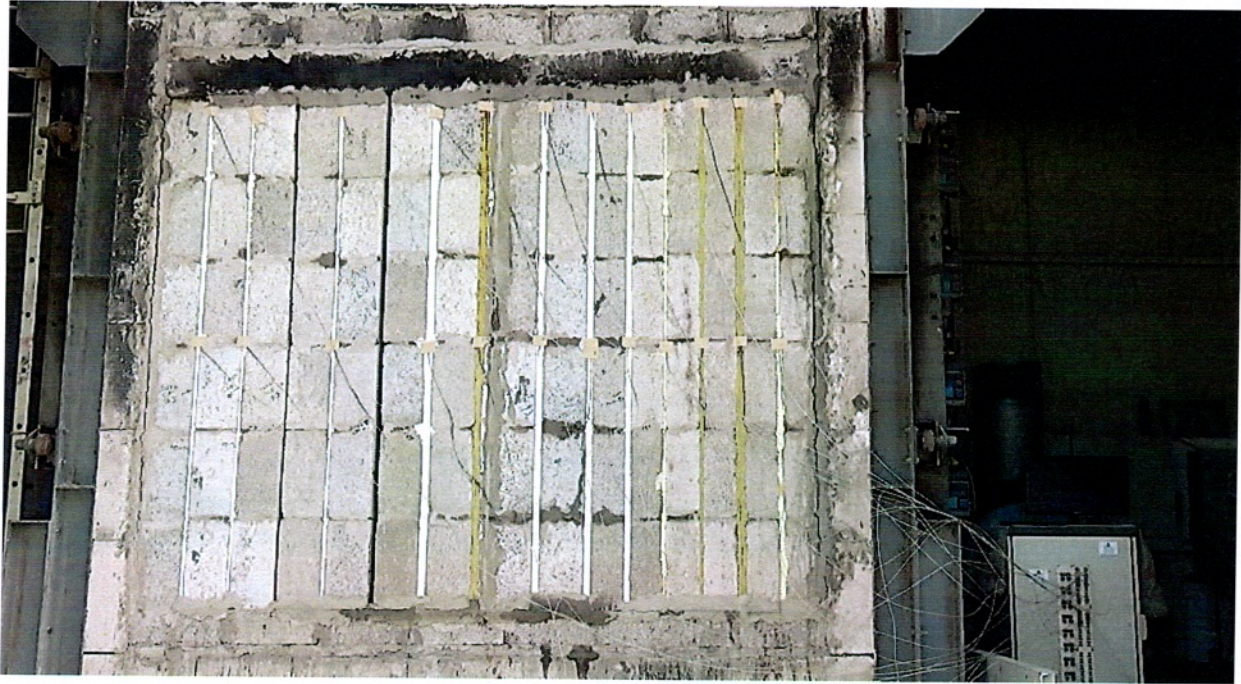
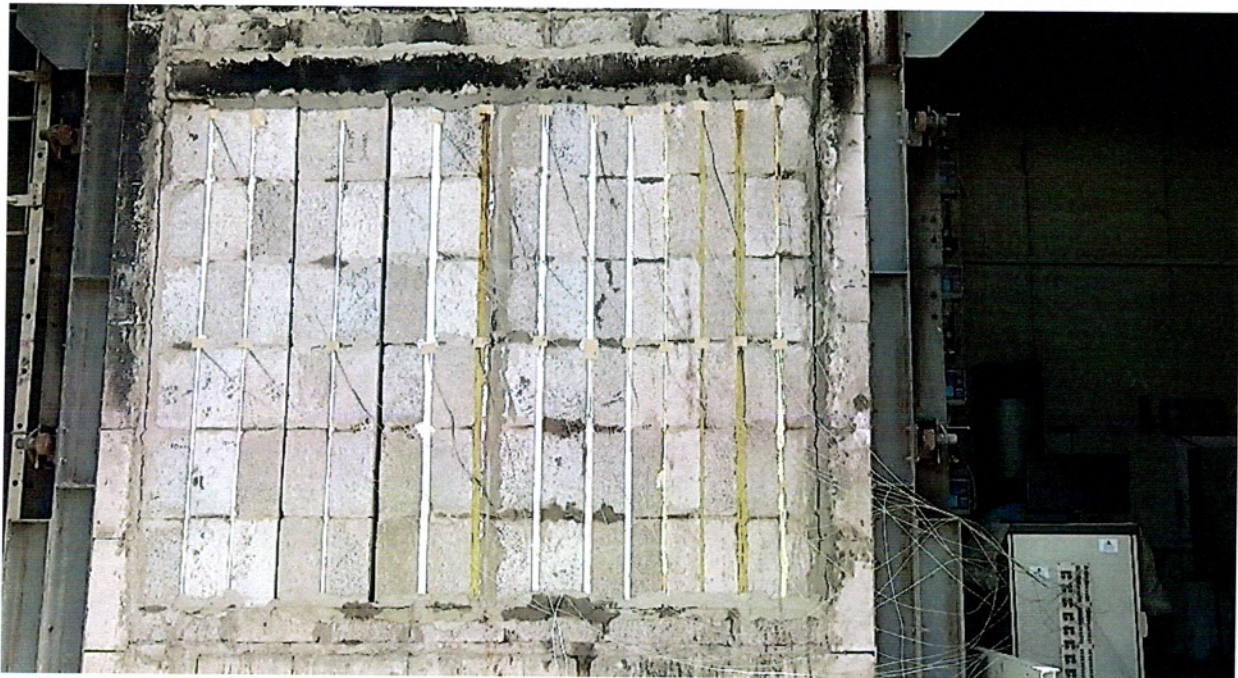
Specimen after 90mins of testing

Specimen after 120mins of testing

Figure 14.2: Unexposed side of specimen during exposure to fire

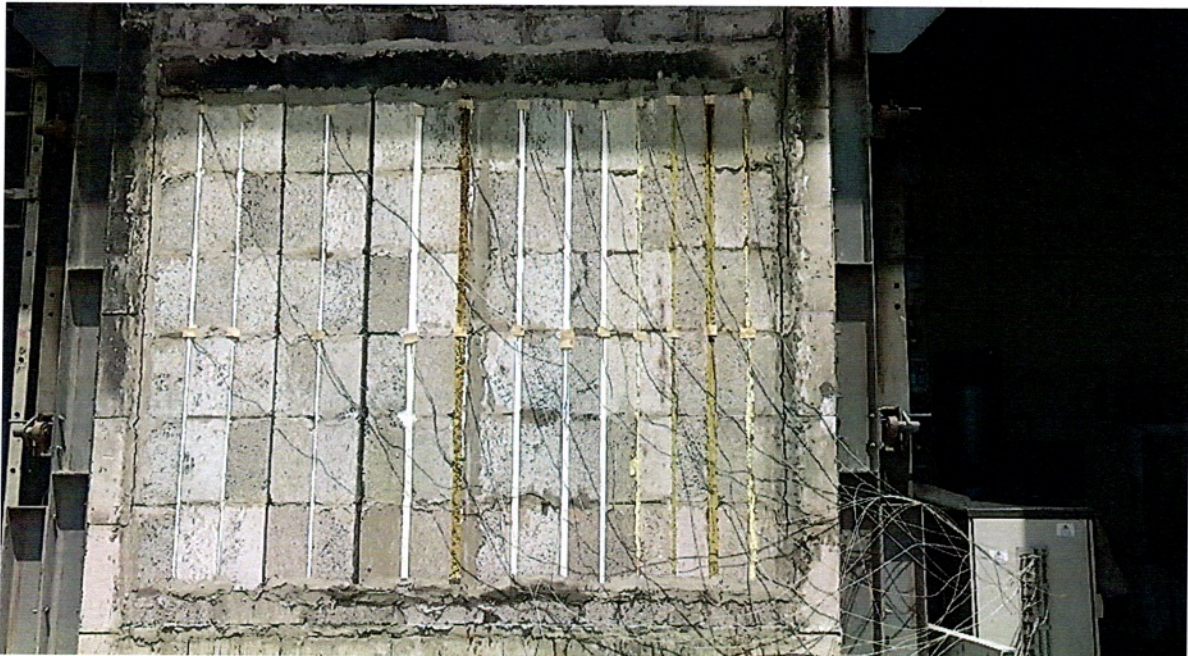
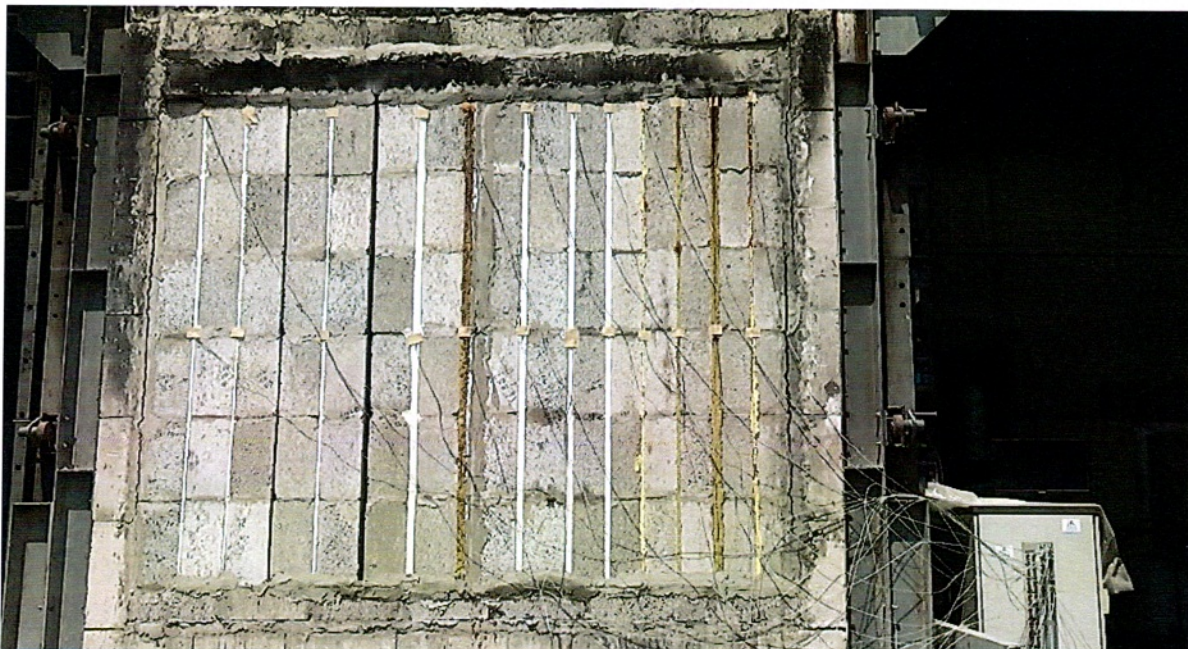
Specimen after 180mins of testing

Specimen after 240mins of testing

Figure 14.3: Unexposed side of specimen during exposure to fire
